## **Preliminary field observations of Muri shoreline and lagoon**

Fieldwork undertaken by Eddie Beetham and Tracey Turner

31 October 2016 – 5 November 2016

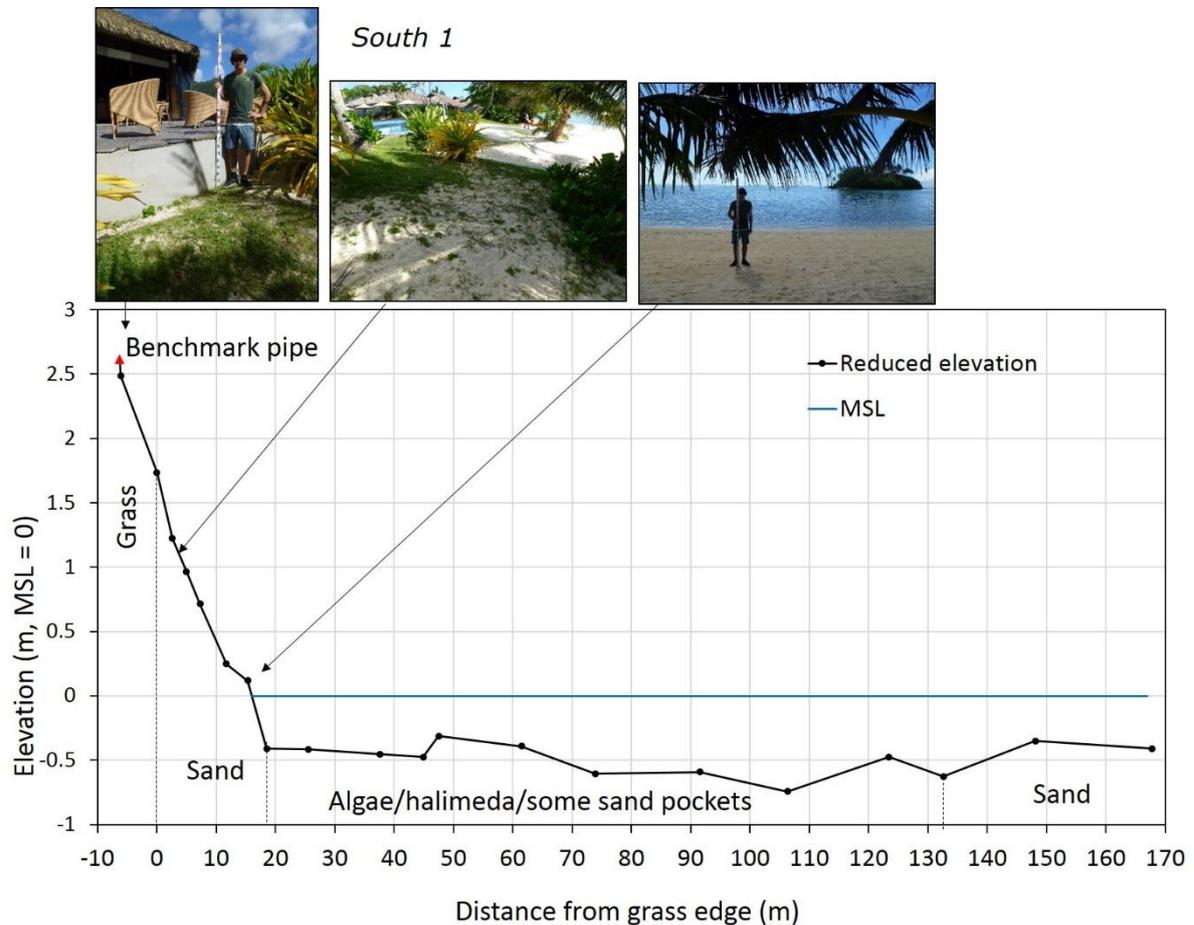
Figure 2: South 1 profile, with elevation relative to MSL = 0 m.

**Summary:** Grass covered upper beach at resort transitions into 20 m wide sandy beach comprised of medium grain sand. Lagoon is covered in algae with a strong presence of Halimeda and some sand pockets. Average lagoon depth approximately 0.5 m.

- The shoreline at Nautilus resort is a good example of successful soft-engineering of the shoreline using sculpted dunes and extensive planting of vegetation.

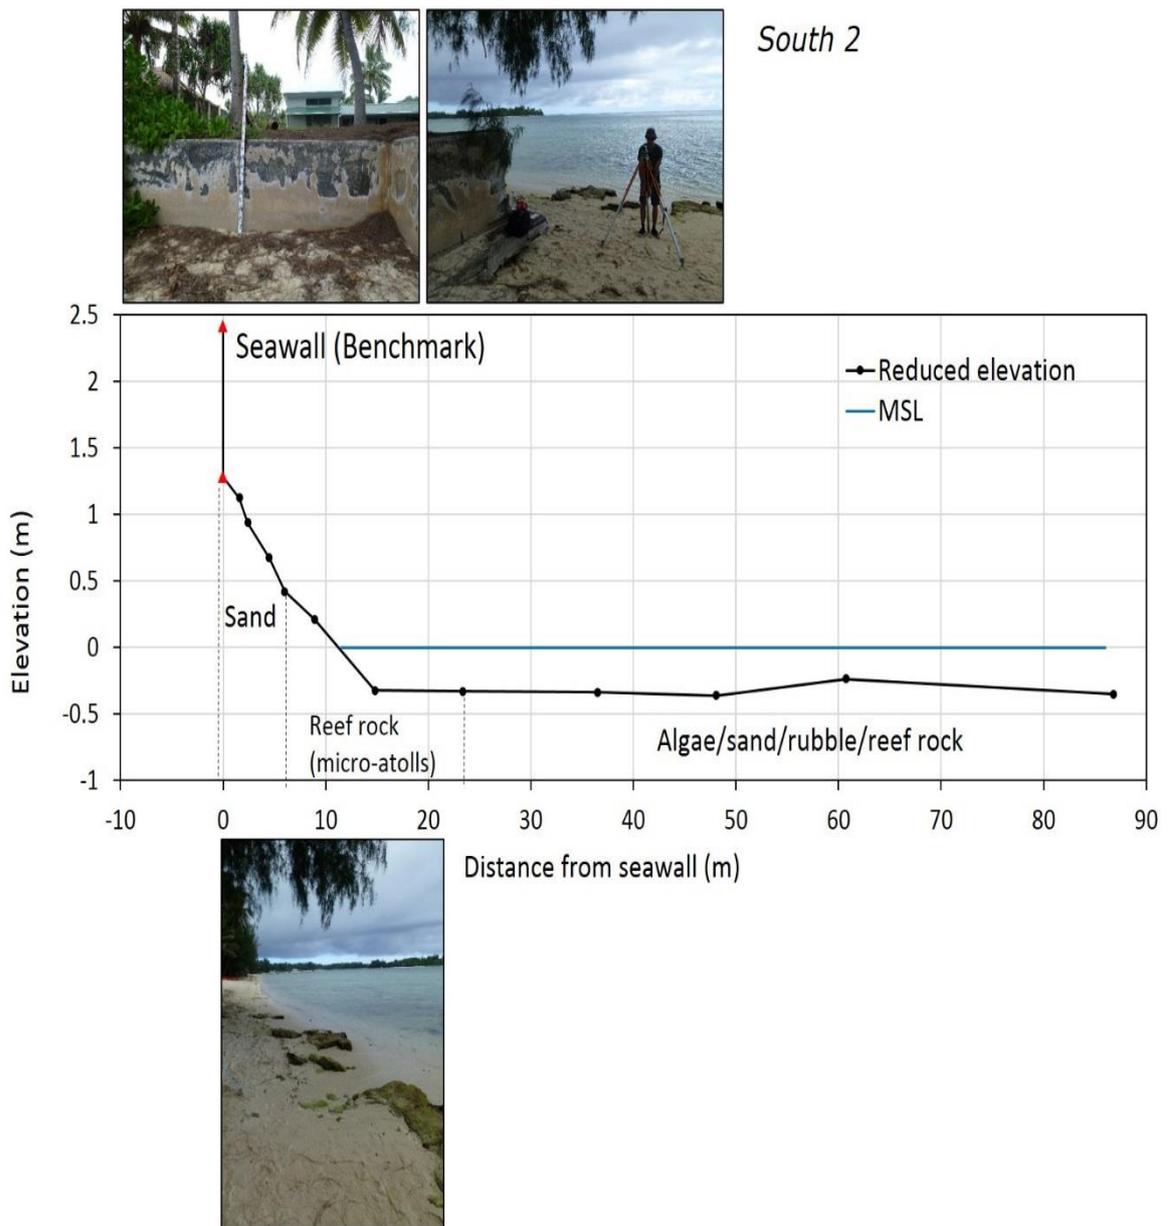
Figure 3: South 2 profile with elevation reduced to MSL = 0 m.

Seawall extends seaward, very close to mean sea level contour resulting in no effective beach space. Beach toe is characterised by a field of fossil micro atoll

formations that lead into the lagoon which has some sand and rubble pockets amongst more reef rock. Lagoon is heavily covered in algae.

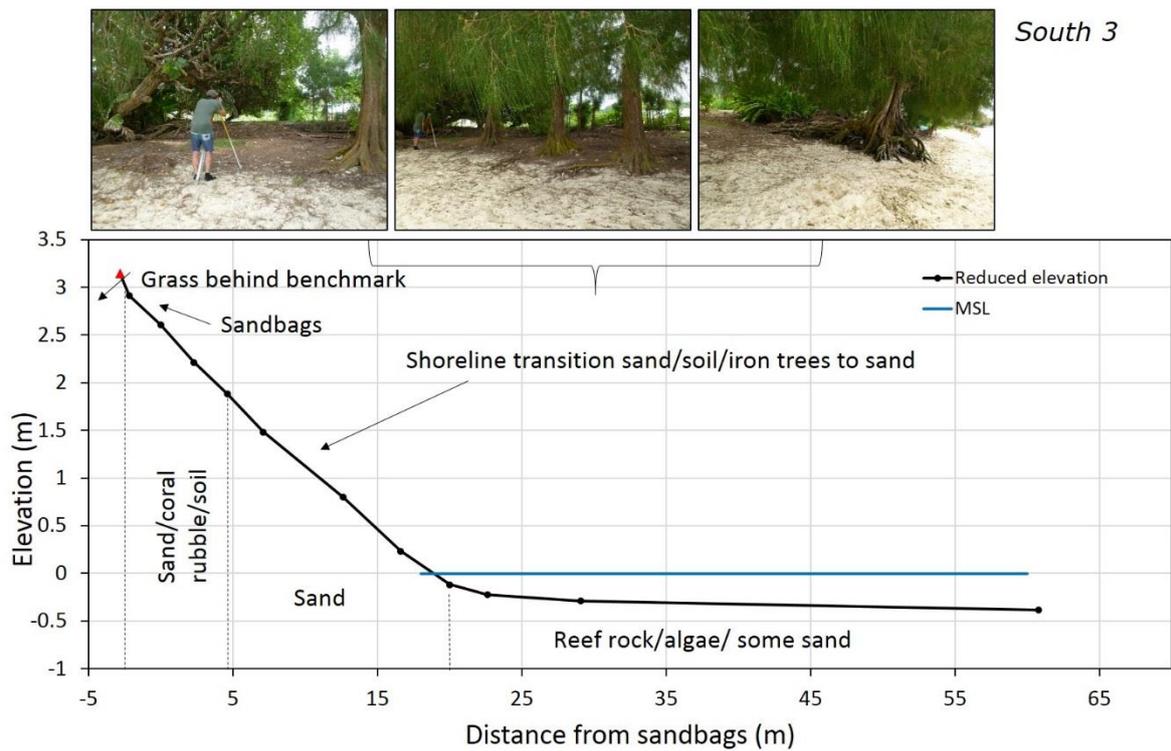
Figure 4: South 3 profile with elevation reduced to MSL = 0 m.

Local property with seemingly natural shoreline characterised by trees (with some root level erosion) with a soil layer over upper beach sand transitioning in to a 10 m wide sandy beach. Inner lagoon is characterised by reef rock, algae with some sand pockets.

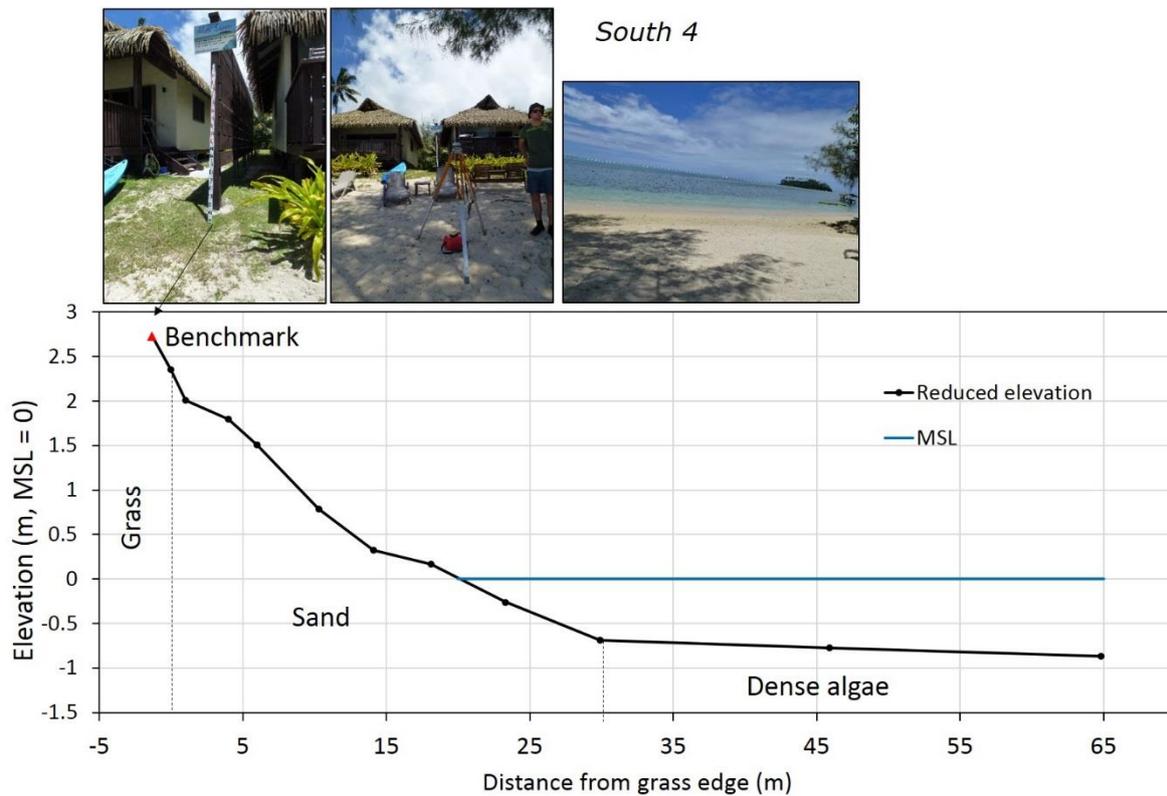
Figure 5: South 4 profile with elevation reduced to MSL = 0 m.

Set-back sandy beach, approx. 20-30 m landward of neighbouring properties engineered shorelines. No vegetation to stabilise shoreline sediment. Sandy beach area extends 18 m width (above MSL). Lagoon characterised by a gradual slope reaching a depth of 0.9 m 45 m from the beach toe. Very dense algae cover.

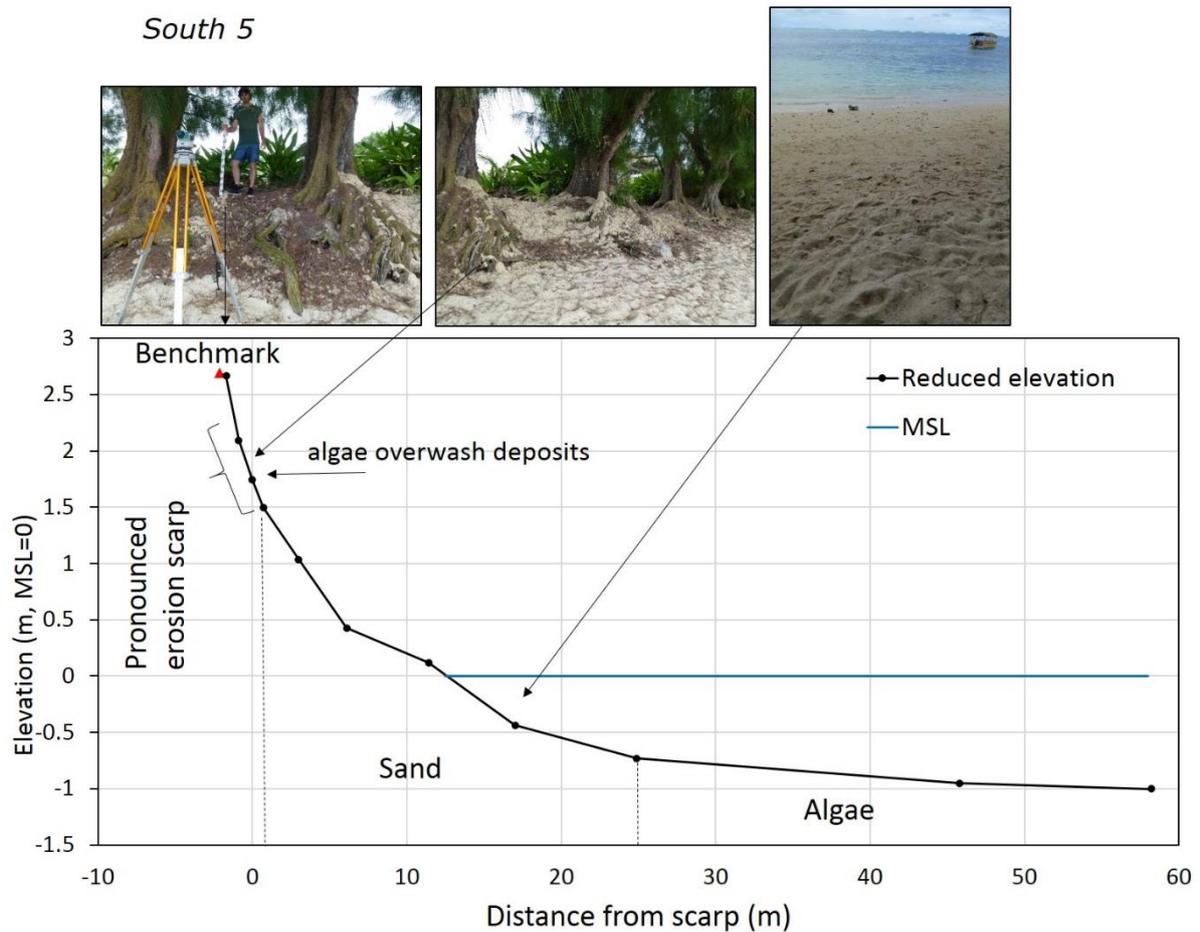
Figure 6: South 5 profile with elevation reduced to MSL = 0 m.

High level of erosion evident on trees at shoreline, with vertical scaring up to 1 m and undercutting of tree base / root system. Sandy beach approximately 12 m wide (above MSL). First 10 m of lagoon is shallow and sandy, remaining seaward section of lagoon is covered in thick algae.

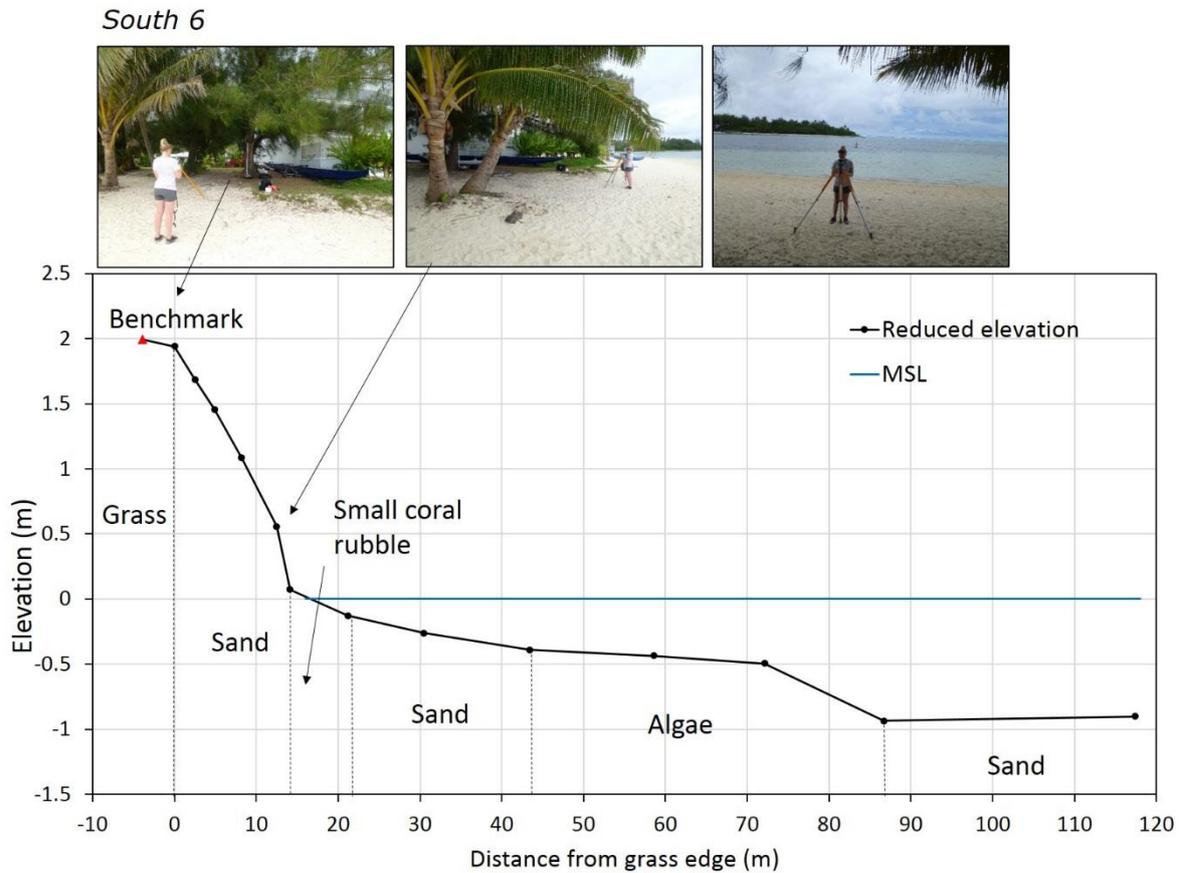
Figure 7: South 6 profile with elevation reduced to MSL = 0 m.

Tree covered grass area transitions into 40 m wide sandy beach area that slopes into the lagoon. Lagoon is initially sandy without algae but algae cover a prominent through the mid lagoon shoreward of the deeper section near the end of the survey.

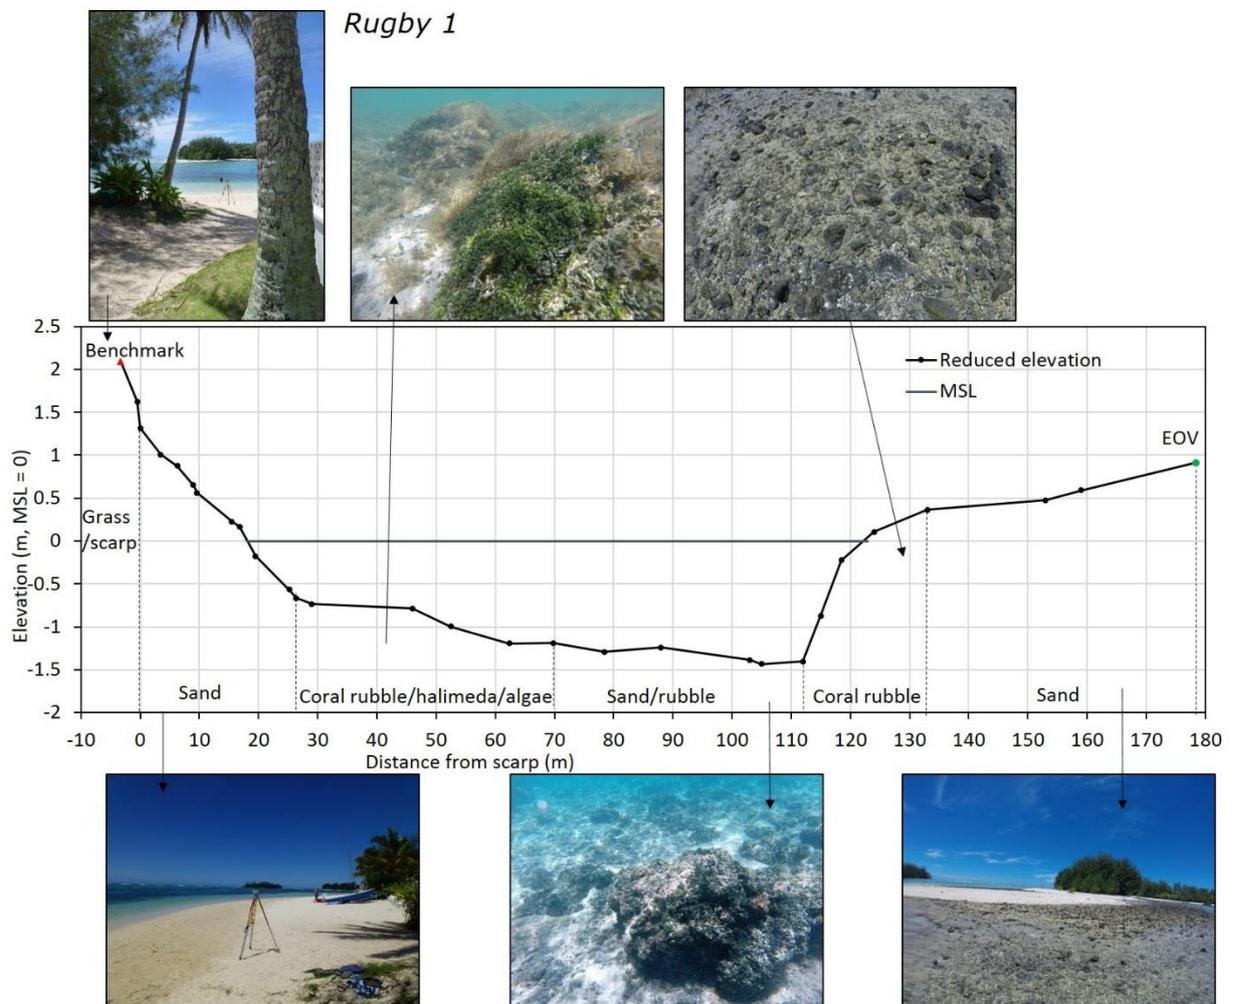
Figure 8: Rugby 1 profile with elevation reduced to MSL = 0 m.

Sandy beach face (18 m wide, above MSL) leads into a lagoon that becomes progressively deeper until reaching the leeward shore of Koromiri. Max depth 1.5 m below MSL in channel near Koromiri. Shallower side of lagoon covered in algae, with coral rubble, halimeda and some porites corals. Profile crosses a driveway area (top left photo). The survey site is valuable because it marks a transition point. To the South of this survey point, the beach is wider, but

characterised by strong tourist development. To the North, lies the Rugby Field, which has a narrower beach face, and is characterised by ad hoc attempts to armour the shoreline from erosion. Markers of erosion are pronounced directly North of this survey location.

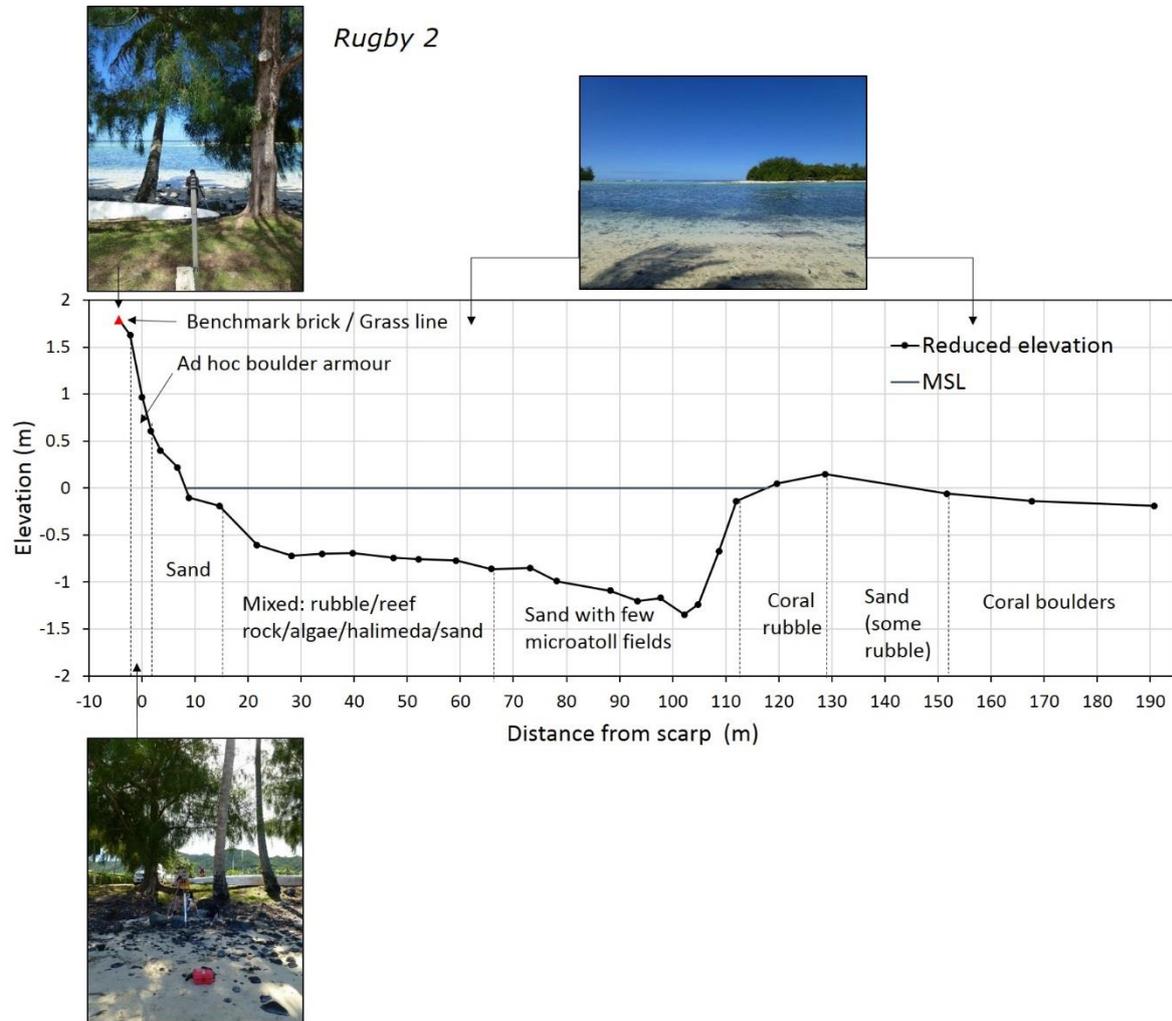
Figure 9: Rugby 2 profile with elevation reduced to MSL = 0 m.

Upper beach face has remains of an ad-hoc rubble armour structure (mix of gravel, pebble and boulder size material). No real sandy beach area above MSL.

Lagoon has thick, wide area of algae, with a high presence of Halimeda and some coral (micro-atoll fields) amongst sand and rubble sections. The lagoon is deepest (1.4 m below MSL) just before the sandbar feature that extends in a South direction from Koromiri to Motu Oneroa. The section of the spit near MSL is approximately 50 wide. New coconut seedlings on the leeward side of Motu Koromiri suggest that the island is prograding South West from the Motu.

- **Removal of ad-hoc shoreline armour material (pebbles and boulders). These loose material may be assisting the removal of sand material from the shoreline during events where small waves wash up on the beach. For an area such as Nukupure Park, a hard engineering solution is not recommended because these structures often limit the formation of a recreational beach.**

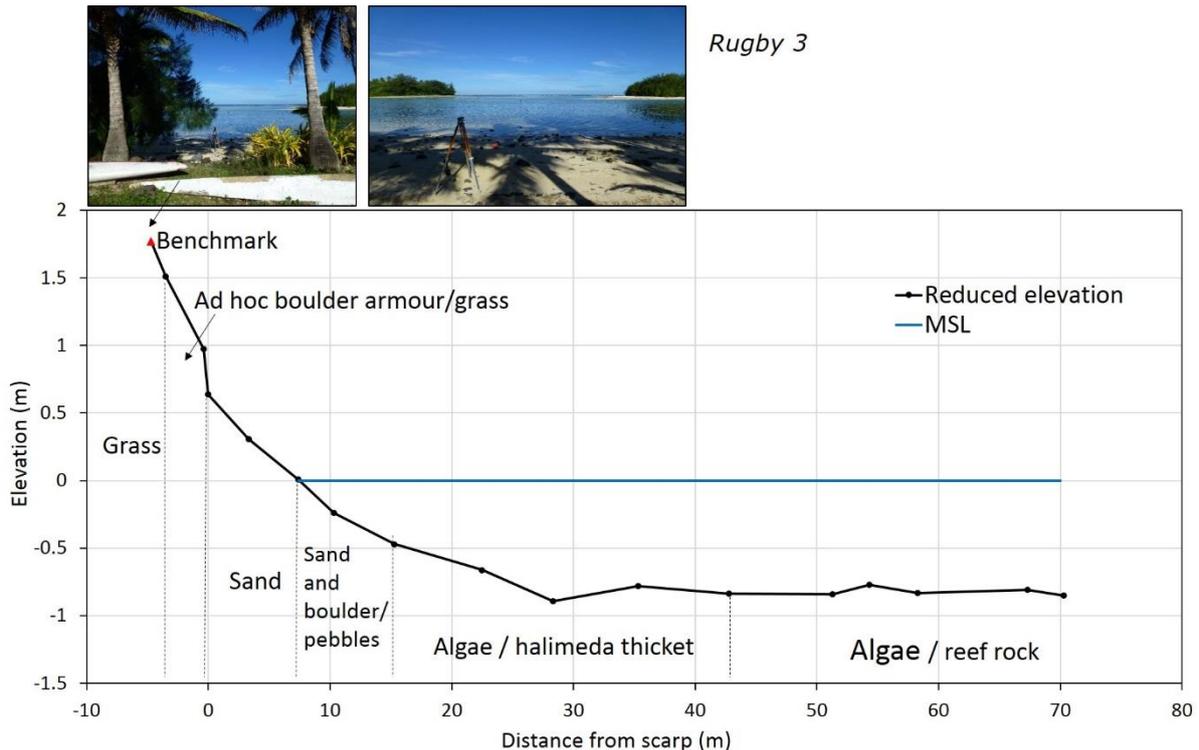
Figure 10: Rugby 3 profile with elevation reduced to MSL = 0 m.

Shoreline characterised by erosion scarps and exposed Ironwood Tree root systems with remains of an ad-hoc rubble armour structure (mix of gravel, pebble and boulder size material). No sandy beach area before the lagoon. Line of pebble sized material formed at beach toe (likely washed off the ad-hoc

rampart) that extends 150 m to the north (see Fig. 15). Surveyed area of the lagoon characterised by algae, halimeda and reef rock approximately 0.8 m below MSL.

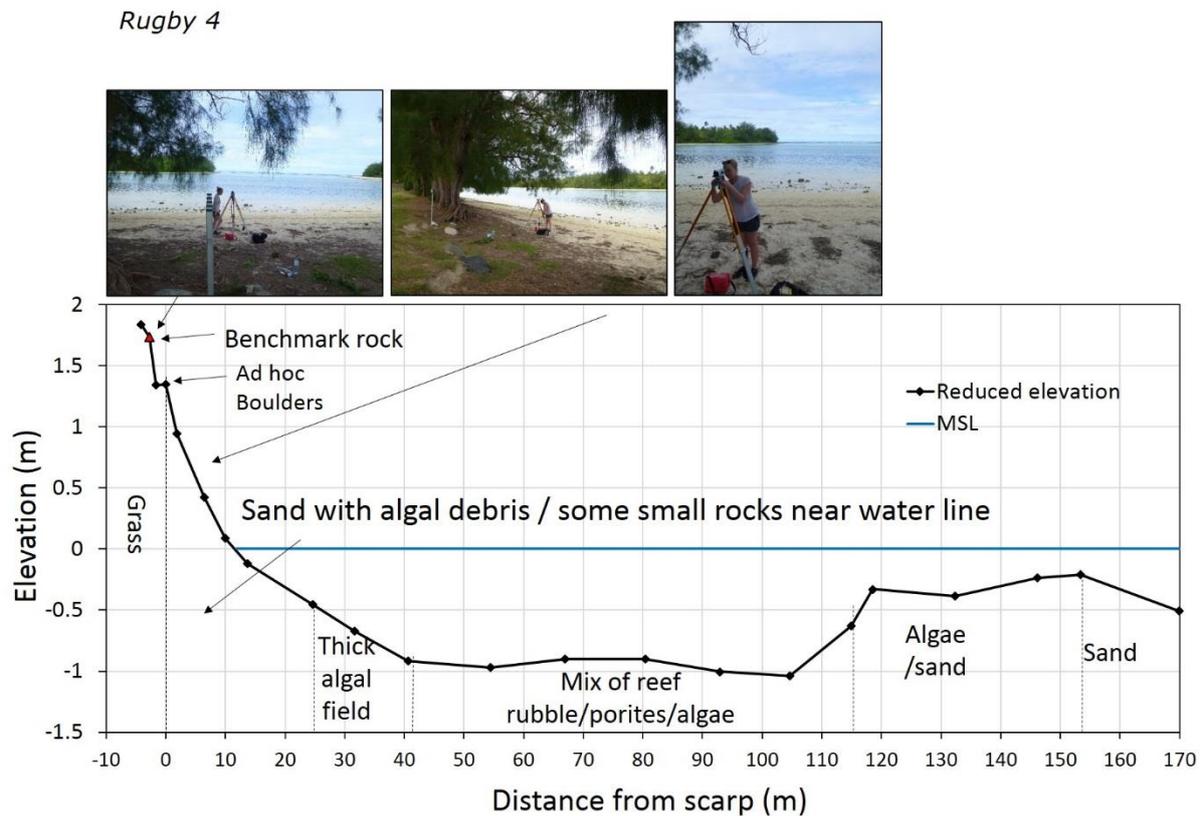
Figure 11: Rugby 4 profile with elevation reduced to MSL = 0 m.

Shoreline characterised by erosion scarps and exposed Ironwood Tree root systems with remains of an ad-hoc rubble armour structure (mix of gravel, pebble and boulder size material). No sandy beach area before the lagoon. Line of pebble sized material formed at beach toe. Lagoon between shoreline and

sand bar characterised by algae, halimeda and some coral, with a mean depth approximately 0.9 m below MSL and no pronounced channel. Sandbar heavily colonised by algae.

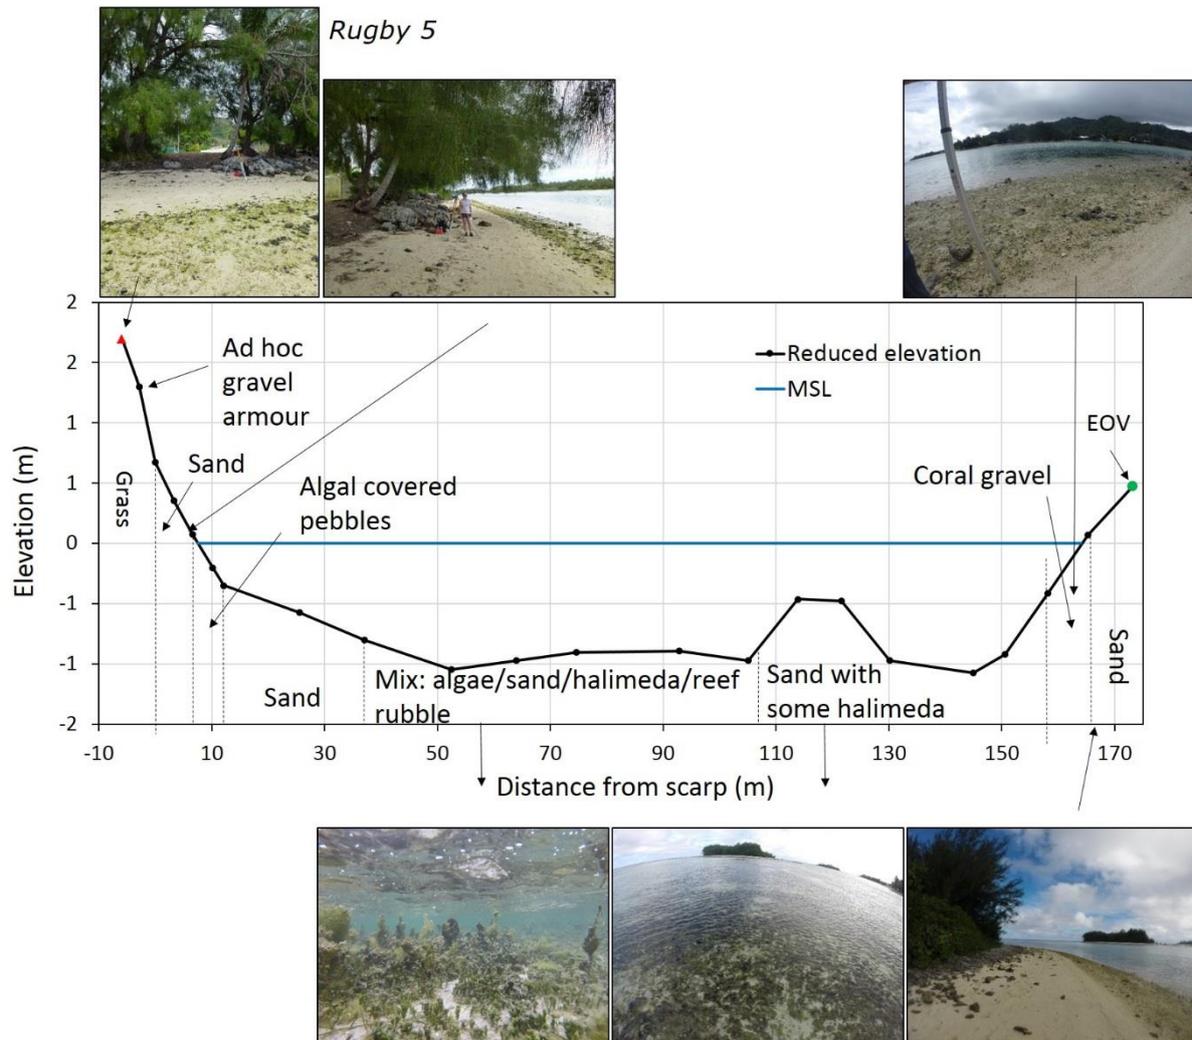
Figure 12: Rugby 5 profile with elevation reduced to MSL = 0 m.

Northern section of the rugby field has boulder sized aggregate material scattered in an ad-hoc attempt to prevent erosion. Marked erosion was observed on the shoreline, with undercutting and scarring of Ironwood trees. Beach toe

characterised by pebble size material initially used for shore protection that has washed off the berm and is being transported northward. No sandy beach face. Lagoon becomes gradually deeper for 30 m before reaching a thick algae zone, with some halimeda, sand, rubble and coral. Profile crosses the spit / sand bar feature that extends off of Motu Koromiri that is separated from Oneroa by a 20 m wide, 1 m deep channel.

- **A vegetated beach nourishment solution may be more suitable for Nukupure Park, to improve recreational amenities and protect the shoreline from further erosion.**

- At Nukupure Park nourished sediment will be required to build up the beach (vertically, landward and seaward) for this to be effective. Stabilising shrubs should be planted to assist deposition and prevent easy erosion.

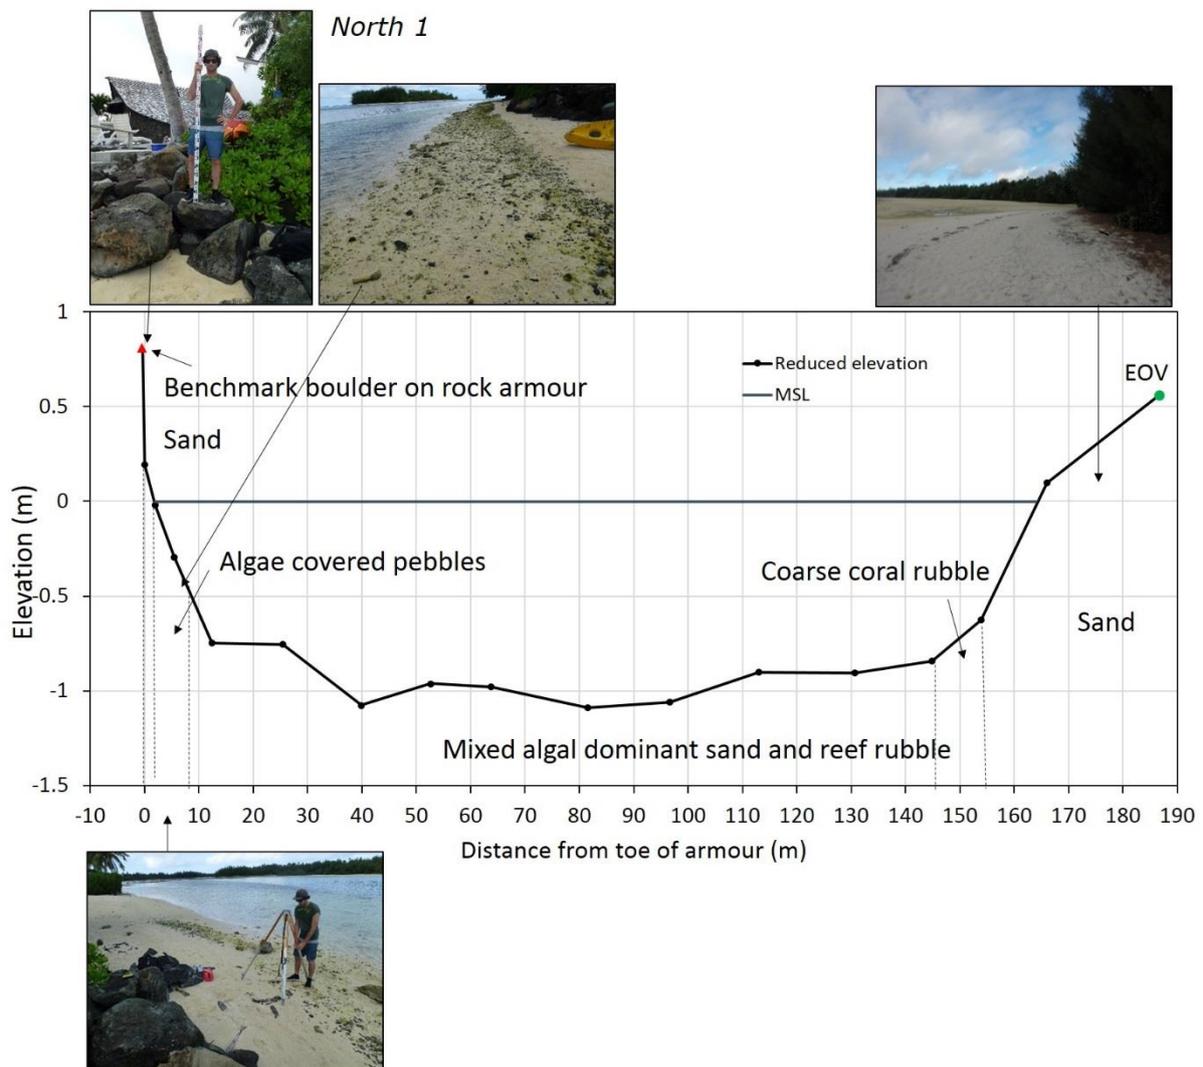
Figure 13: North 1 profile with elevation reduced to MSL = 0 m.

**Summary:** Armoured shoreline with narrow sandy beach area. Shoreline quickly transitions into lagoon with a mean depth approximately 1 m below MSL. Lagoon floor is covered in algae with patches of sand and rubble. Leeward shore of Oneroa is initially rubble dominant then becomes sandy. Oneroa is 162 m away from mainland (MSL contour).

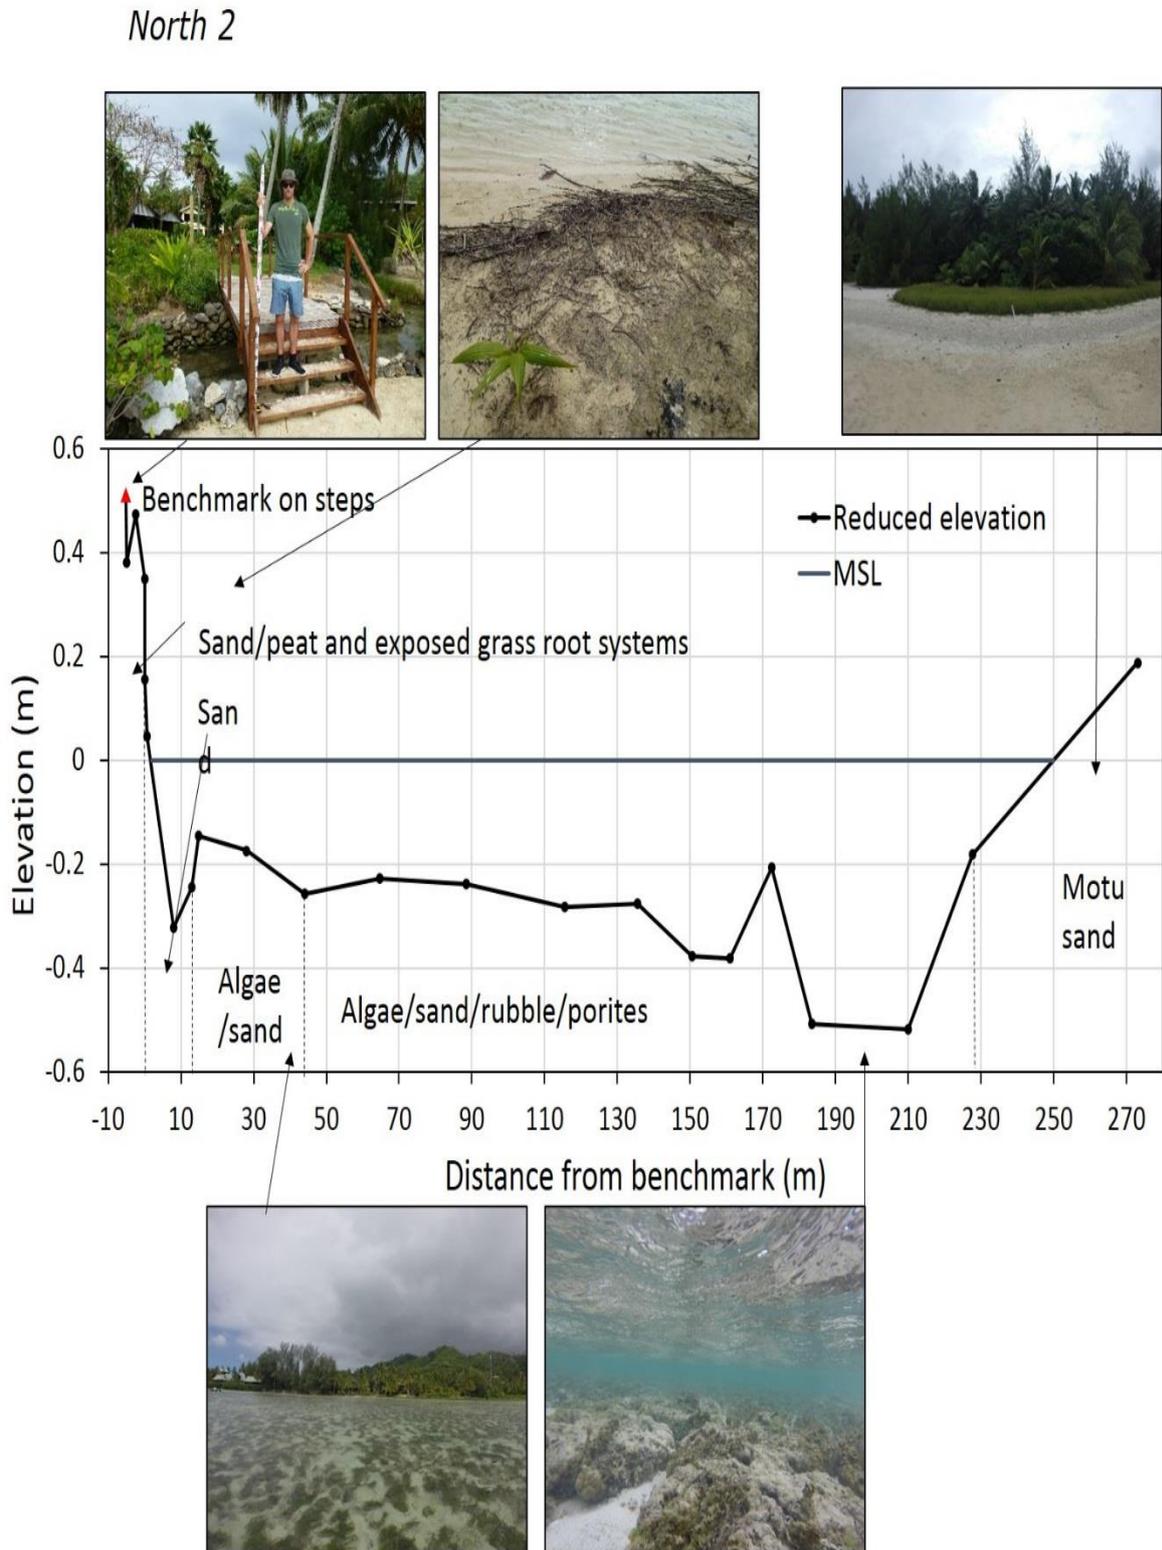
Figure 14: North 2 profile with elevation reduced to MSL = 0 m.

**Summary:** Low elevation spit feature (seaward of stream) has marked vegetation (grass) erosion. Shoreline scars into lagoon, with the landward section characterised by algae and sand. The lagoon becomes gradually deeper towards Oneroa, characterised by algae, sand, rubble and some porites coral. Deepest section of lagoon is near Oneroa, approximately 0.5 m below MSL. Distance between Oneroa and mainland at the MSL contour is 248 m.

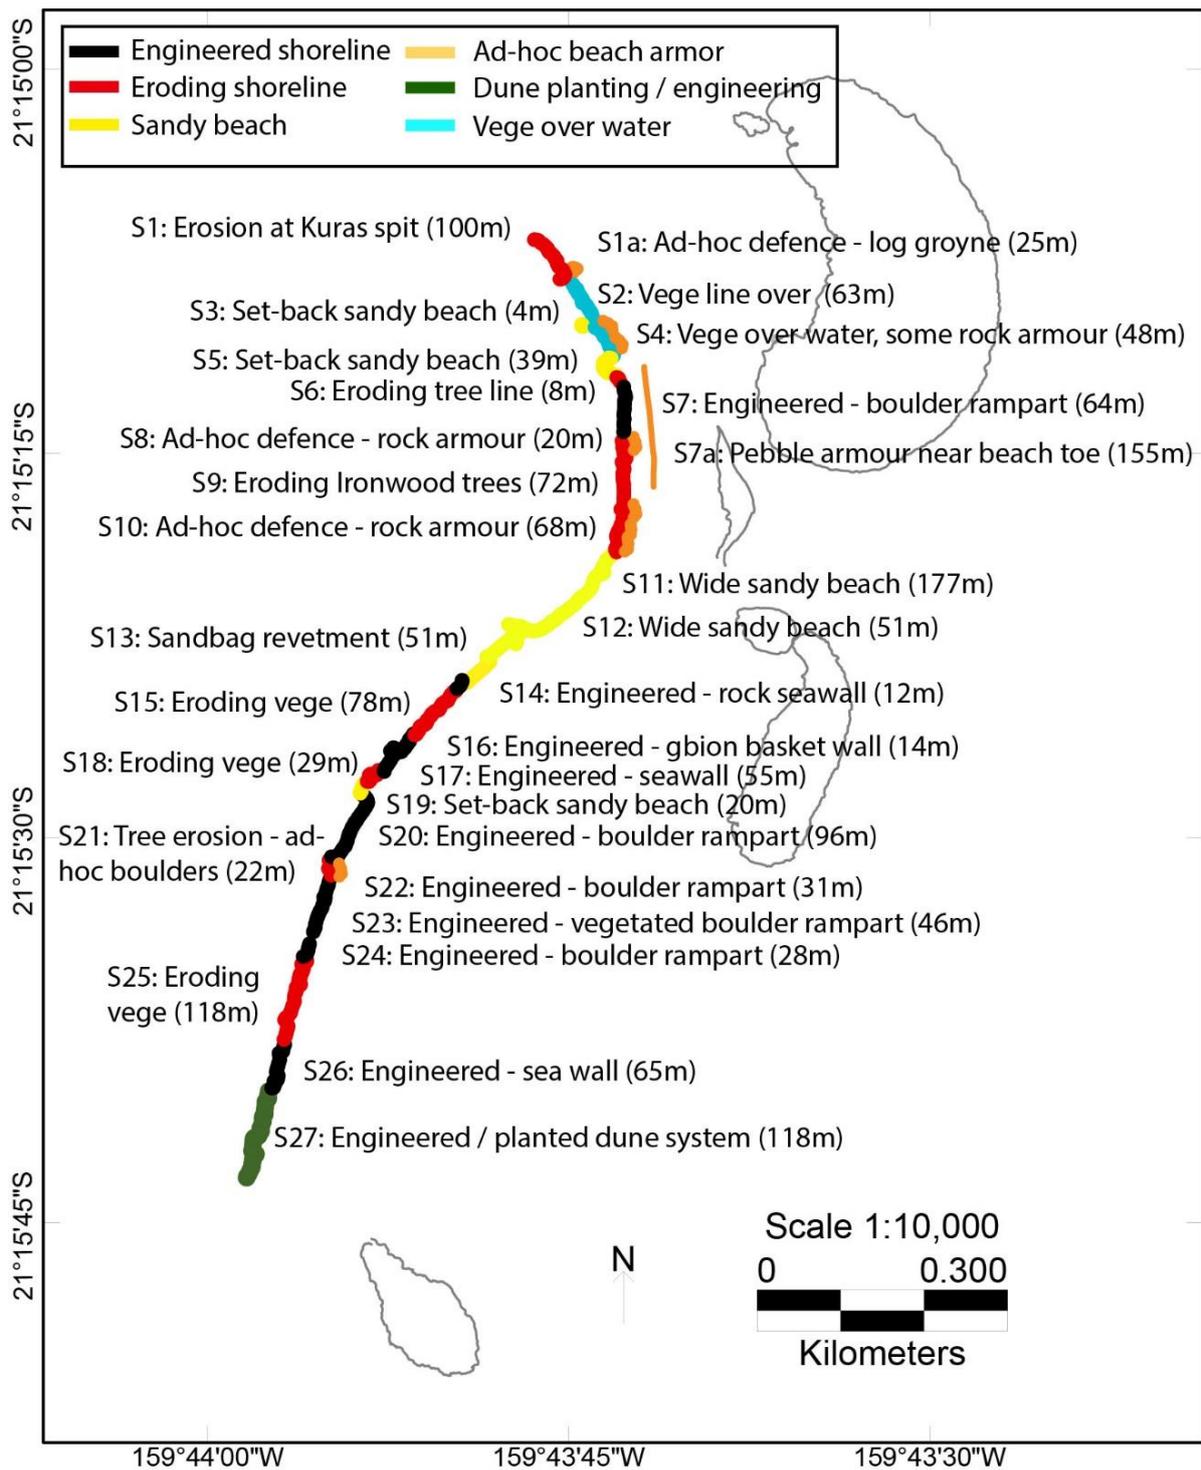
Figure 15: Map showing shoreline characteristics

Within the 1,500 m long study area, 42% of the shoreline was characterised by marked erosion of trees or other vegetation. Areas with pronounced erosion include Nukupure Park and a number of private properties north of the sailing club. The base of Ironwood trees at Nukupure Park are heavily scarred, showing the root systems. Large trees north of Muri Shores have erosion scarps ranging between 1-1.5 m high and are undercut by up to 2.5 m.

A number of resorts and other accommodation developments / services on the beach front have introduced hard engineering structures. These include large boulder ramparts, concrete or wooden seawalls and gabion basket walls and collectively account for 27% of the surveyed area.

Poorly designed *Ad-Hoc* coastal defence features have been implemented across 11% of the shoreline, mostly associated with private and public beach front land. These include pebble, gravel and boulder size rocks at the rugby field, an attempted groyne made of logs and rocks south of the rugby club and large boulders in front of tree outside Koka Lagoon Cruse. This ad-hoc attempt has likely exacerbated erosion in areas, especially the loose rocks on the rugby field. A few small accommodation providers (4% of survey) have a sandy beach that is set-back 20-30 m landward of neighbouring properties that have engineered shorelines. These set-back beaches preserve the 'natural' shoreline characteristics but are not vegetated, suggesting natural vegetation has been removed to facilitate access and beach views. Private land also shows evidence of attempts to protect the shoreline from erosion, with ad-hoc sandbagging, and the placement of large coral boulders around well-established tree roots (such as large coconut palms) in an attempt to prevent overtopping.
